# UNDERWATER FACILITIES INSPECTIONS & ASSESSMENTS

NAVAL AIR  
STATION  
NEW ORLEANS, LA.

FPO-1-85-(18)

JUNE 1985

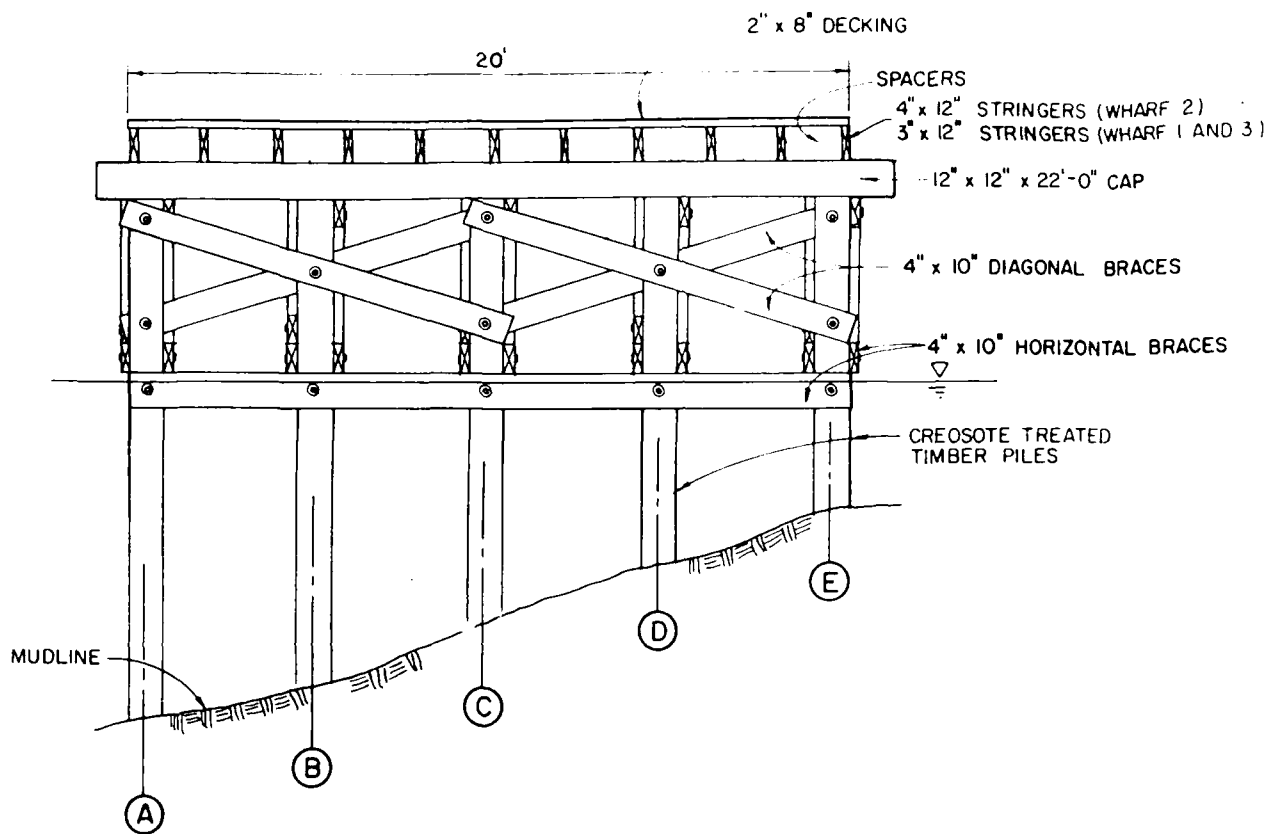
FIG NO  
3

Fuel Wharf 128 is a timber structure, constructed on the Intracoastal Canal in approximately 1959. The facility consists of three wharves, with connecting catwalks, an approach ramp, and an electrical pumphouse. A total of 90 creosote treated timber piles support the structure. The wharf provides mooring and unloading facilities for barges which supply aviation fuel utilized at the Naval Air Station. Maximum water depth recorded at the facility during this inspection was 10 feet. (See Figure 3 for Pile Plan and locations of observed inspection conditions. See Figures 4 and 5 for Sections and Construction Details.)

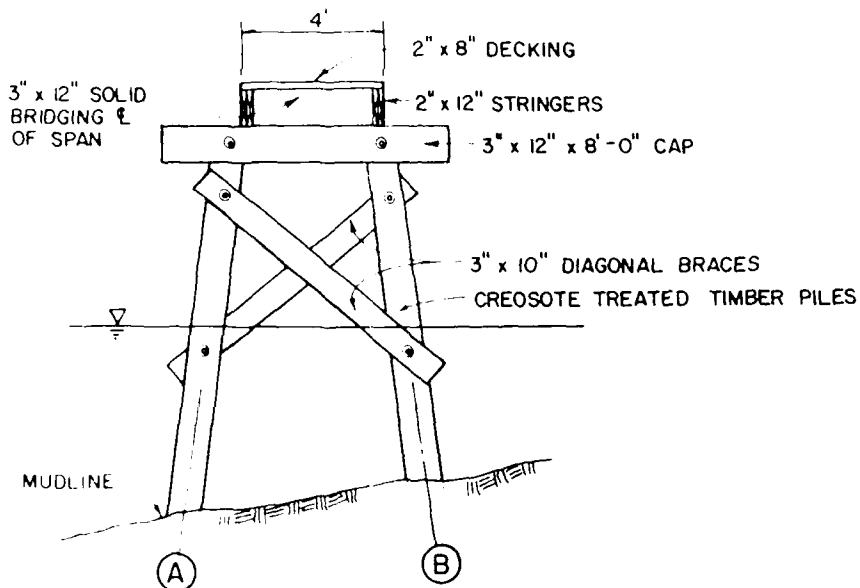
SCALE IN FEET		NAVAL AIR STATION NEW ORLEANS, LOUISIANA FUEL WHARF 128	FIG NO 4

The overall condition of the structural members was good, although fungal decay was detected at locations throughout the facility. Structural framing consists of two rows of horizontal bracing, diagonal bracing, pile caps, stringers, spacers between stringers, and deck (See Figure 4). All timber framing was creosote treated. The deck appeared to have the greatest number of decayed members, with an estimated 30% showing areas of significant decay (See Photo 8). Although the deck covered the top of the stringers, possibly obscuring some deterioration, decayed areas were noted in approximately 5% of the stringers (See Photos 9 and 10). The caps were the most extensively decayed members. Deterioration of the cap members usually occurred in the horizontal surfaces where moisture could accumulate. Three outer caps and one interior cap exhibited deterioration (See Photos 11 and 12). It should be noted that many areas where decay could occur were obstructed by framing members. For example, the upper portions of the stringers were covered by the deck, and the caps were covered by stringers, spacers, and the deck.
